City of Alexandria Storm Sewer Capacity Analysis (CASSCA) Corrugated Metal Pipe Condition Assessment

PREPARED FOR: City of Alexandria, CH2M Hill
PREPARED BY: Michael Baker Jr., Inc.
DATE: November 16, 2013

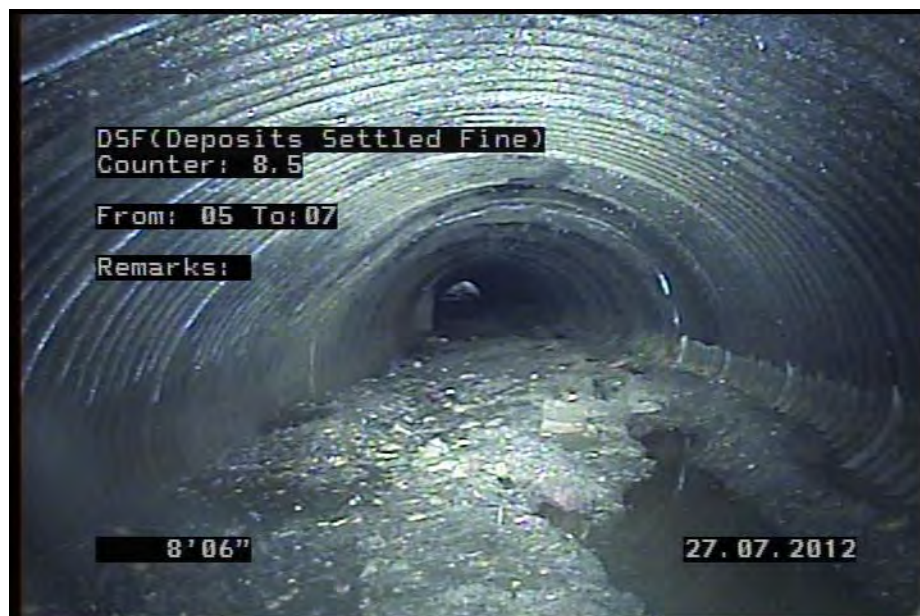
Figure 6. Settled Deposits.
Segment 011898STMP, Four Mile Run, SCREAM Score = 47

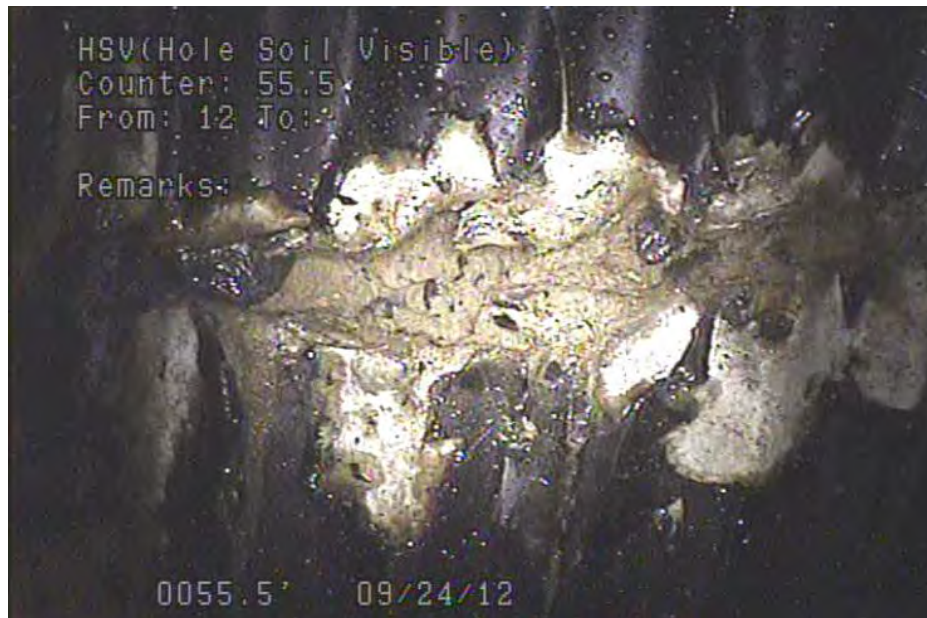
Figure 7. Soil Visible Through Hole in Pipe Wall.
Segment 014553STMPHolmes Run, SCREAM Score = 97

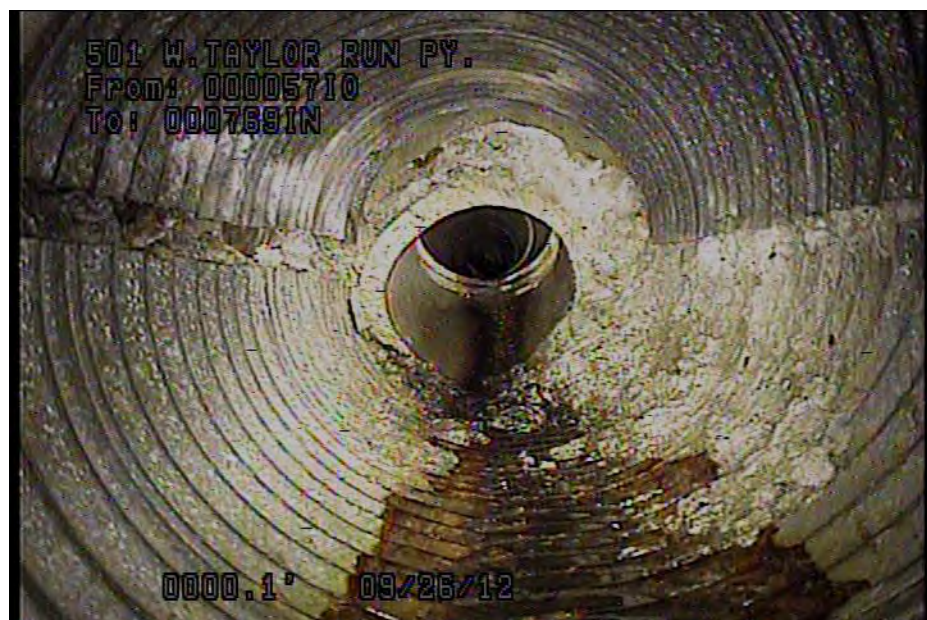
Figure 8. Horizontal Pipe Wall Separation.
Segment 000822STMP, Taylor Run, SCREAM Score = 100

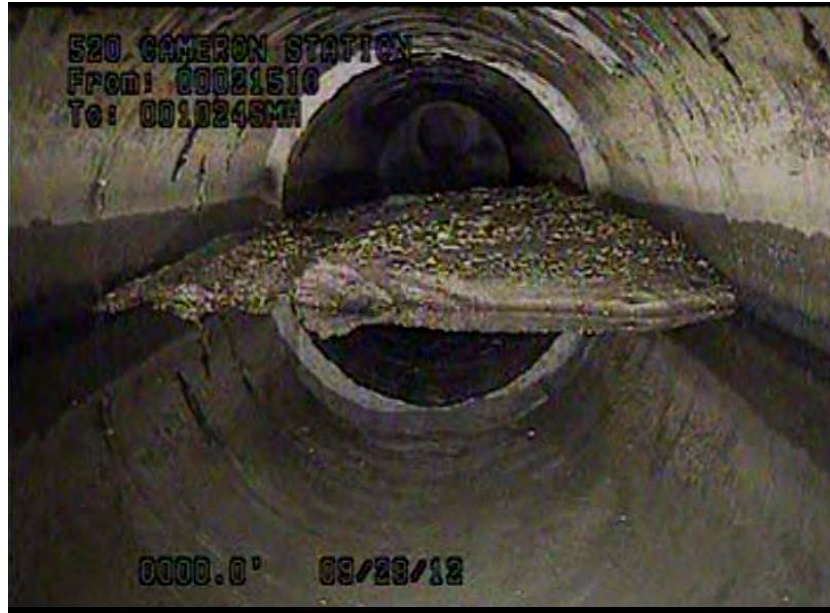
Figure 9. Heavy Debris Accumulation and Standing Water.
Segment 004805STMP, Backlick Run, SCREAM Score = 94

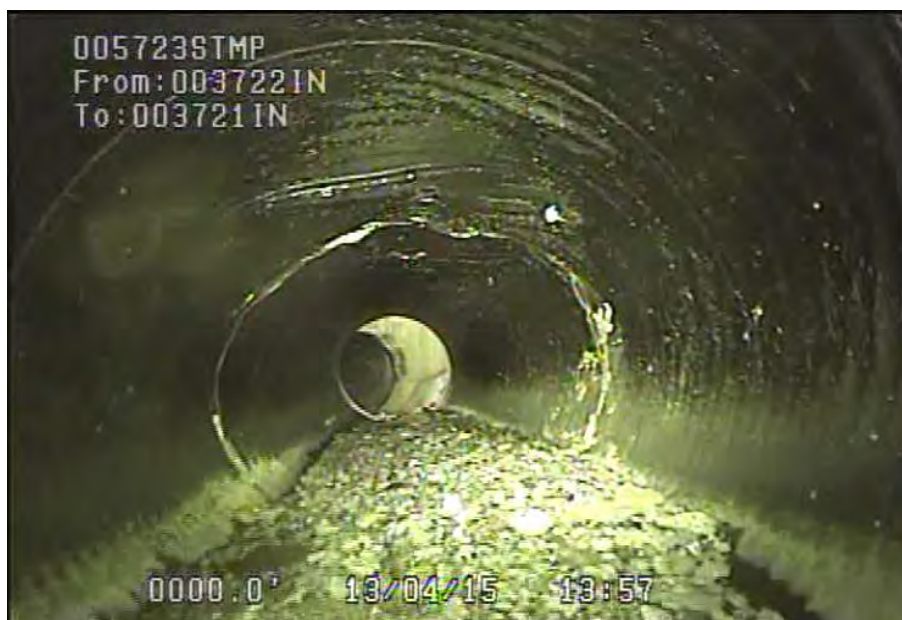
Figure 12. Deformed Pipe Crown.
Segment 005723STMP, Cameron Run, SCREAM Score = 70

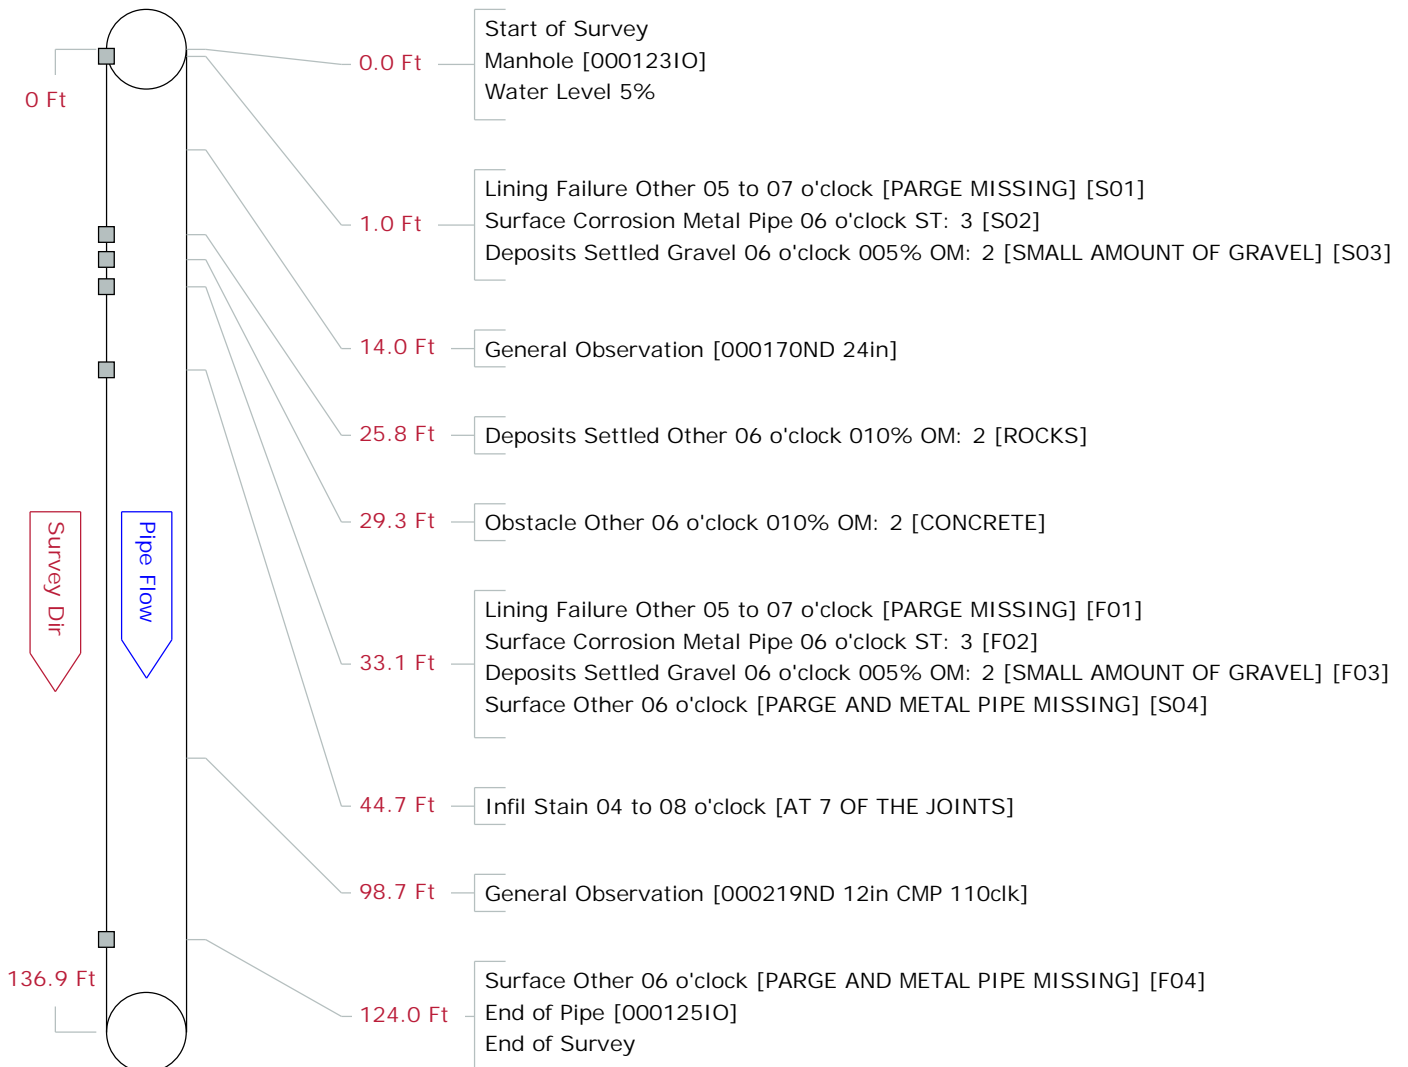
Pipe Graphic Report of PSR 004805STMP

008278IN	008301IN	POTOMAC RIVER	2300 JEFFERSON DAVIS	10/08/12	yes	yes	no	PBroPe3	95	Pipe	Broken, Pieces	3 (Hole/Void Visible)
001024SMH	000215IO	BACKLICK RUN	520 CAMERON STATION	09/28/12	no	no	yes	PDSet40	92	Pipe	Debris Settled	40% Area Loss
002276IN	002275IN	HOLMES RUN	320 N JORDAN ST	08/28/12	no	yes	no	PBroPe1	85	Pipe	Broken, Pieces	1 (Pieces Displaced)
005623IN	002635SMH	HOOFS RUN	501 RICHARDS LN.	07/17/12	no	yes	no	PBroPe1	85	Pipe	Broken, Pieces	1 (Pieces Displaced)
000123IO	000125IO	STRAWBERRY RUN	3731 DUKE ST.	04/11/13	no	yes	no	PCor2	80	Pipe	Corrosion	2 (Aggr. Visible)
003298IN	001073SMH	HOLMES RUN	633 N.RIPLEY ST.	09/25/12	no	yes	no	PCor2	80	Pipe	Corrosion	2 (Aggr. Visible)
000769IN	000057IO	TAYLOR RUN	501 W.TAYLOR RUN PY.	09/26/12	no	yes	no	JDis3	78	Joint	Displaced	3 (>1.5 Pipe Thickness)
001024SMH	000215IO	BACKLICK RUN	520 CAMERON STATION	09/28/12	no	yes	no	PCor2	77	Pipe	Corrosion	2 (Aggr. Visible)

Setup	9	Surveyor	SMU	Certificate #	U-809-9223		System Owner	CITY OF ALEXANDRIA			
Drainage	BACKLICK RU			Survey Customer	CH2M HILL						
P/O #		Date	2012/09/28	Time	7:49	Street	520 CAMERON STATION				
City	ALEXANDRIA		Further location details (INDEX TILE) H-2b								
Start	000215IO			Rim to invert	0.00	Grade to invert		Rim to grade	Ft		
Finish	001024SMH			Rim to invert	6.70	Grade to invert		Rim to grade	Ft		
Use	Stormwater			Direction	Upstream	Flow control	Not Controlled		Media No	CH2M-9-28	
Shape	Circular			Height	48	Width	ins	Preclean	J	Year Cleaned	2012/09/28
Material	Corrugated Metal Pipe			Joint length	12.0	Ft	Total length	16.4	Ft	Length Surveyed	14.00
Lining				Year laid			Year rehabilitated			Weather	Damp
Purpose	Maintenance Related			Cat							
Additional info	PIPE HAS LARGE AMOUNTS OF SAND&GRAVEL										
Location	Easement/Right of Way										
Project	CASSCA_CCTV_20120923_20120929_SMU

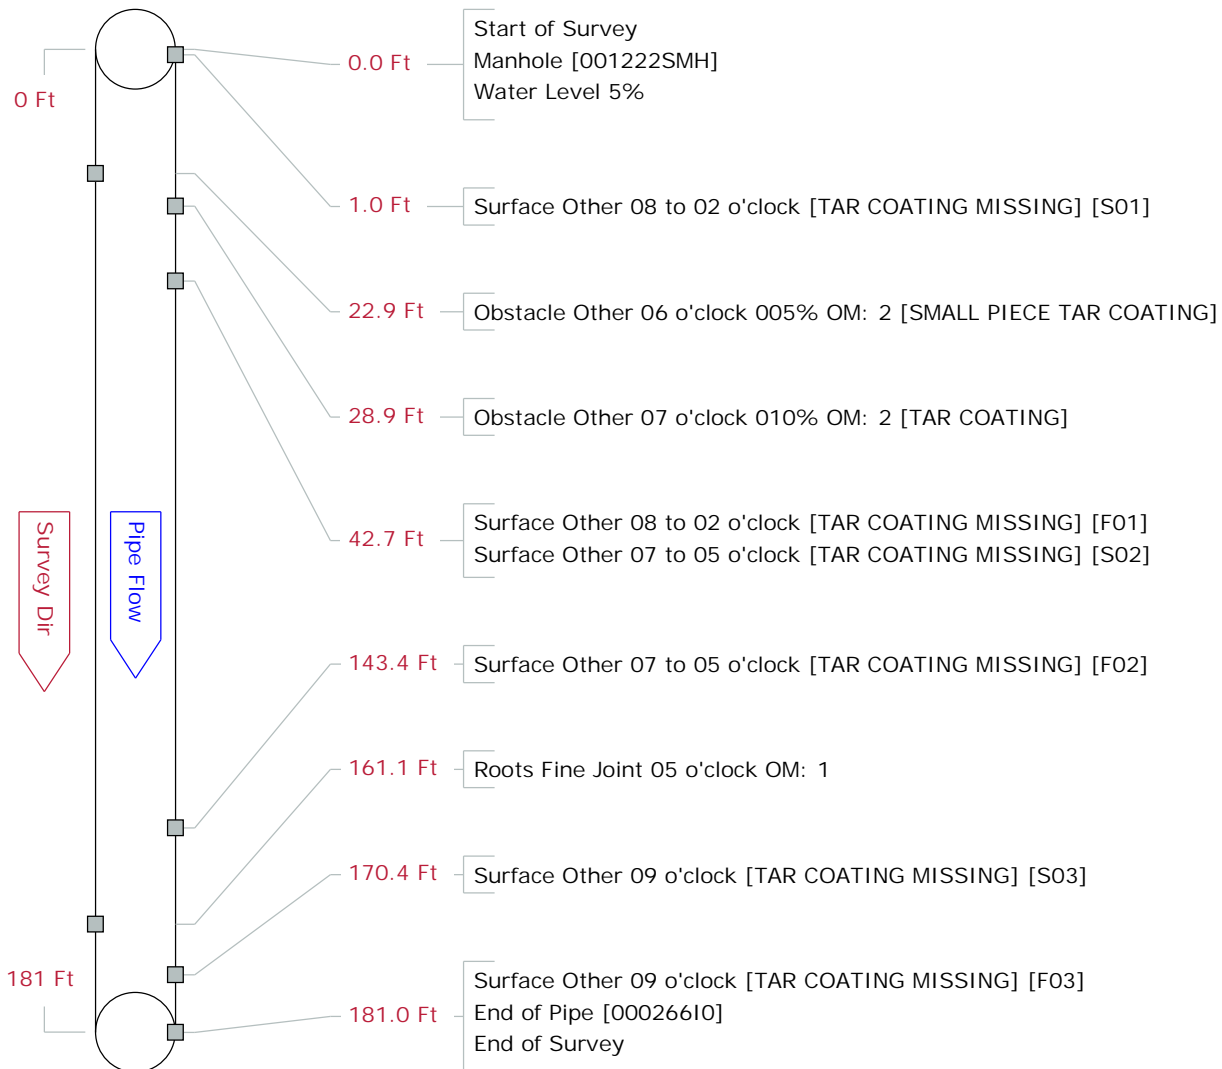
Pipe Graphic Report of PSR 005873STMP

001222SMH	000266IO	HOLMES RUN	332 N.PICKETT ST.	09/24/12	no	yes	no	PCor2	74	Pipe	Corrosion	2 (Aggr. Visible)
002364SMH	002363SMH	POTOMAC RIVER	701 N.FAIRFAX ST.	10/01/12	no	yes	no	JO3	70	Joint	Open	3 (> 1.5 Pipe Thickness)
002371SMH	005126IN	POTOMAC RIVER	402 BASHFORD LA.	10/01/12	no	yes	no	JO2	70	Joint	Open	2 (1-1.5 Pipe Thickness)
003722IN	003721IN	CAMERON RUN	3825.5 DOMINION MI.	04/15/13	no	yes	no	PDef3	70	Pipe	Deformation	3 (11-30% Dia.)
000541IO	007752IN	HOOFS RUN	601 COMMONWEALTH AVE.	07/17/12	no	no	yes	PDep30	60	Pipe	Deposits	30% Area Loss
002371SMH	005126IN	POTOMAC RIVER	402 BASHFORD LA.	10/01/12	no	no	yes	PDSet30	60	Pipe	Debris Settled	30% Area Loss
007990IN	007989IN	HOOFS RUN	426 E.MONROE AVE.	07/20/12	no	no	yes	PDep30	60	Pipe	Deposits	30% Area Loss
003268SMH	002500ND	HOOFFS RUN	1501 CAMERON ST	07/26/12	no	yes	no	PDef3	52	Pipe	Deformation	3 (11-30% Dia.)

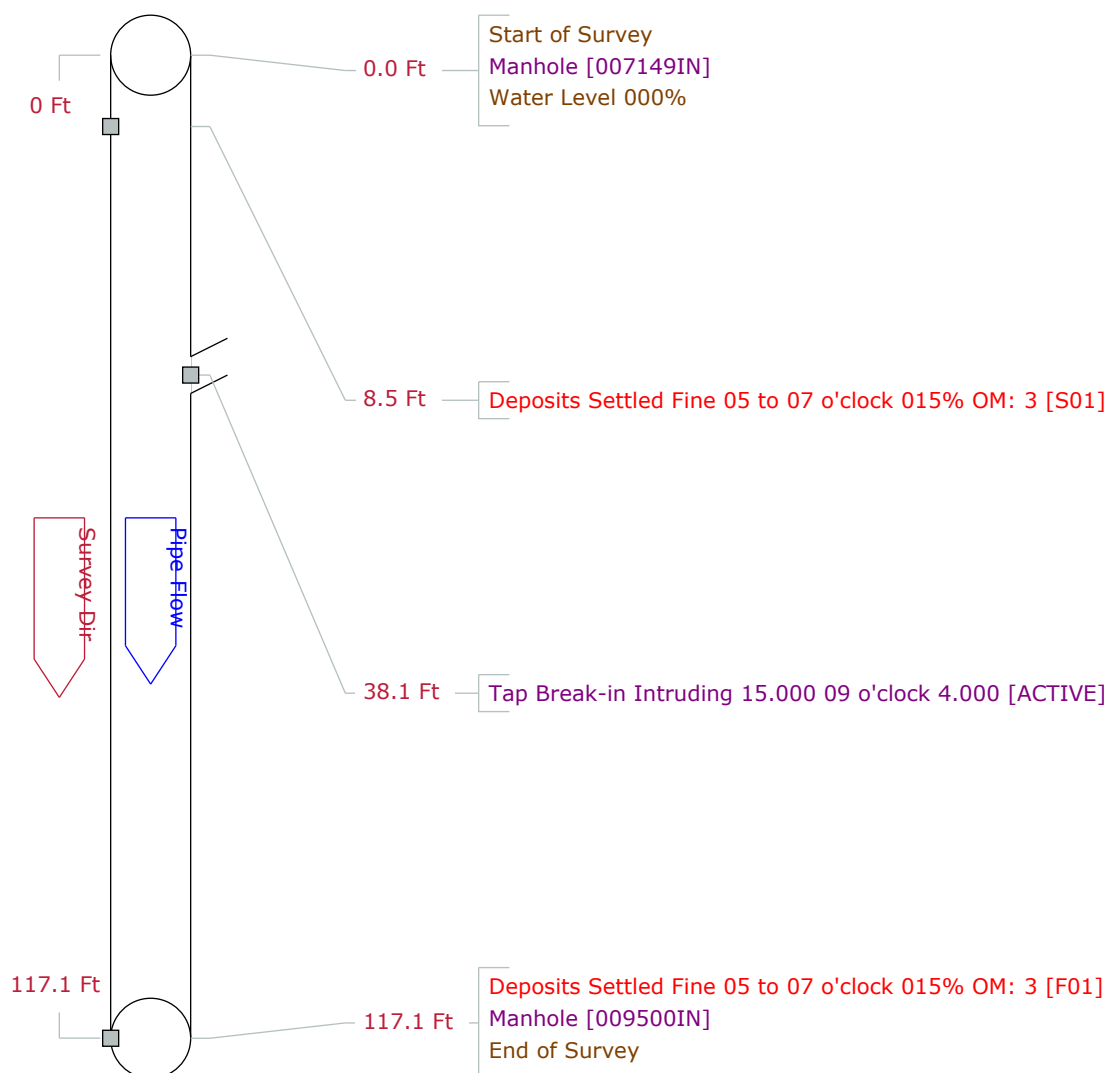
Pipe Graphic Report of PSR 007847STMP

Figure 13. Tap Break-In & Infiltration.
Segment 007847STMP, CSO-Pendleton, SCREAM Score = 42
